## GEOTECHNICAL PROBLEMS IN THE 2011 TOHOKU PACIFIC EARTHQUAKES

### ABSTRACT

An overview of the geotechnical aspects of the building damage in the 2011 Tohoku Pacific earthquake is presented, based on field reconnaissance made after the quake. It is shown that: (1) Extensive soil liquefaction occurred along the coast of Tokyo Bay and around the Tonegawa River floodplain. Liquefaction primarily occurred within relatively new reclaimed area, with large ground settlement up to 60 cm, accompanied by settlement/tilting of wooden and reinforced concrete buildings supported on spread foundations; (2) Numerous houses in Sendai's hilly residential areas constructed with cut-and-fill methods were badly damaged not only by simple collapse of retaining walls, but also by slope failures of fill; (3) Several pile-supported buildings tilted and settled not only in the Tohoku region but also in the Kanto plain, implying damage to pile foundations; and (4) Several steel and reinforced concrete structures in Onagawa were knocked over by tsunami surges, probably after having suffered damage to their pile foundations.

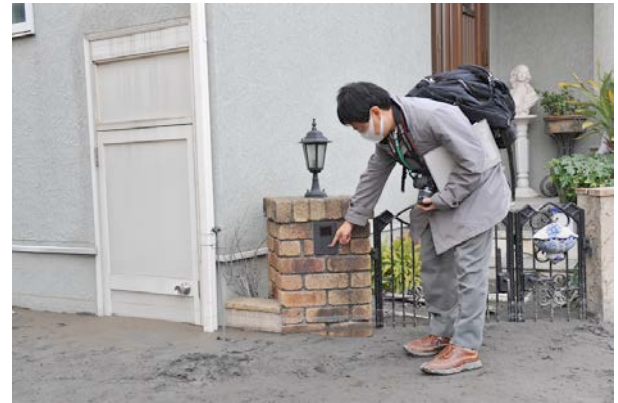
- 1) In the area where liquefaction occurred, many sand boils (Photo 1) and ground settlements were observed. Underground facilities, such as manholes, emergency water tanks and parking lots were uplifted (Photos 2 and 3), tapping water and sewerage systems.
- 2) Many buildings and houses on spread foundations (Photos 4-6) tilted and settled without any damage to superstructure.

Photo 1. Boiled sand and large settlement of house (Tokimatsu et al., 2011)

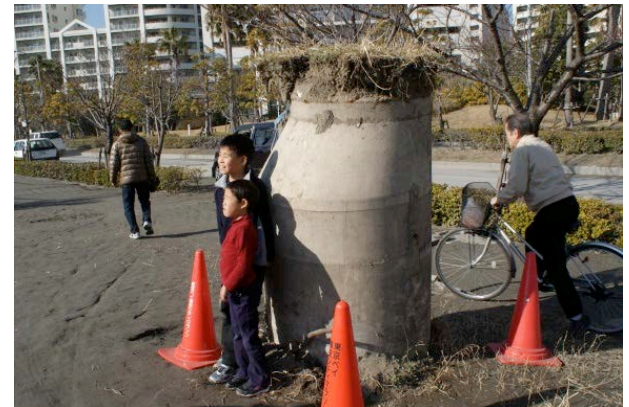
Photo 2. Uplifted manhole (Tokimatsu et al., 2011)

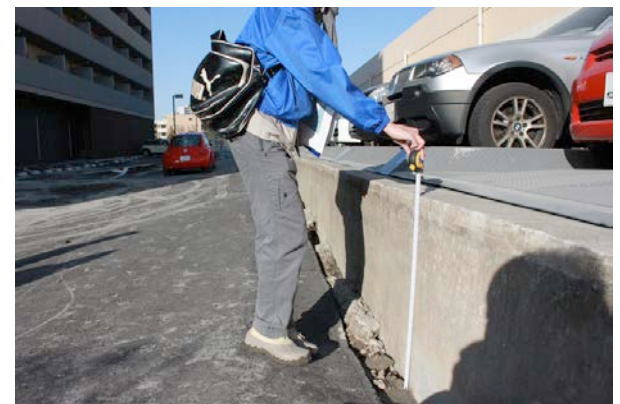
Photo 3. Lifted parking lot (Tokimatsu et al., 2011)

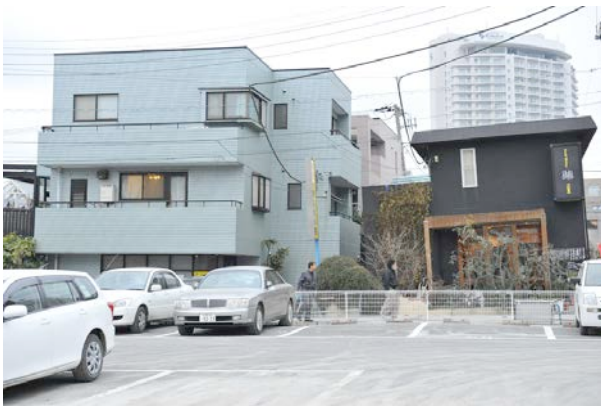
*Photo 4. Largely tilted building (Tokimatsu et al., 2011)*

A close inspection of the damage to houses suggests that, when two buildings stand closely together, they often tilt toward each other, as in Photo 4 and Fig. 14. This is supposed to occur because the ground settlement between the two structures is greater due to their combined weight loads. When buildings face a street, they tend to tilt backward as shown in Photo 5 and Fig. 14, probably because they tended to incline toward the closer buildings located behind them.

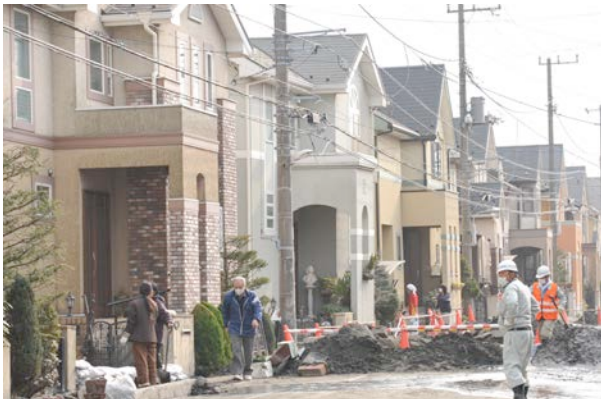
*Photo 5. Tilting houses (Tokimatsu et al., 2011)*

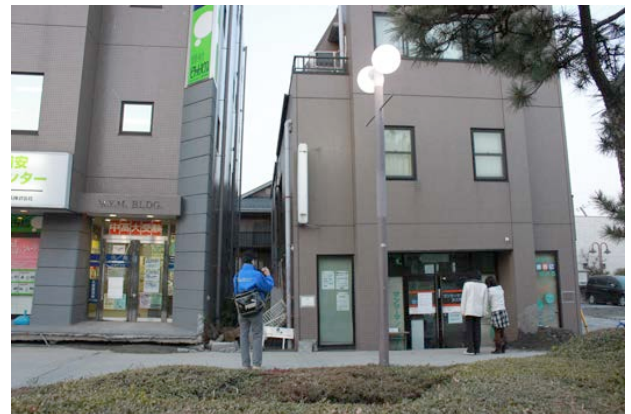
*Photo 6. Pile-supported building and settled building (Tokimatsu et al., 2011)*

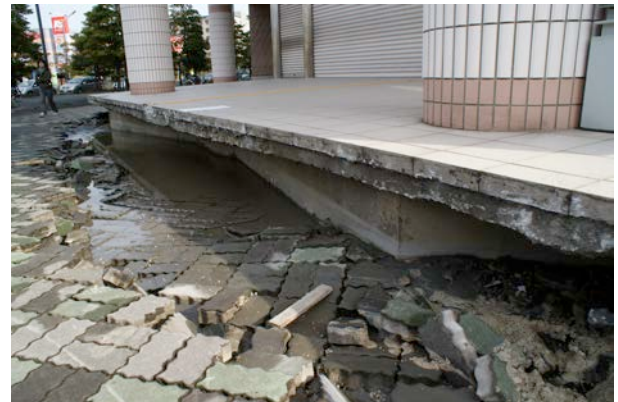
*Photo 7. Pile-supporting building suffering large settlement (Tokimatsu & Katsumata, 2012)*

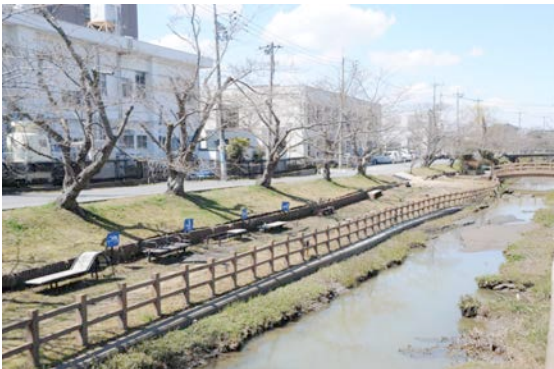
1) Due to liquefaction-induced lateral spreading, the stream became narrow and the riverbed lifted (Photo 8). The ground behind the embankment also settled greatly and shifted horizontally, causing damage to a bridge across the stream.

*Photo 8. Lateral ground spreading towards the river  
(Tokimatsu et al., 2011)*

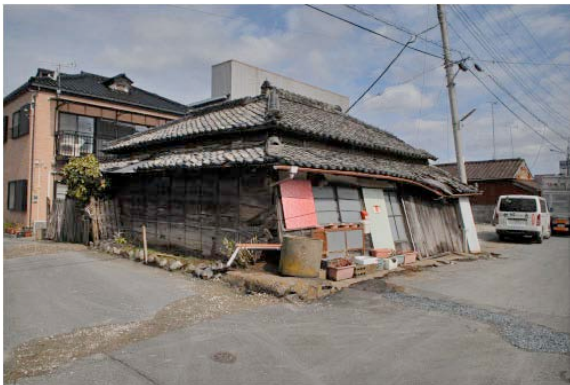
2) Houses and other structures near the embankment had their foundations tilted, as if pushed toward the stream, and some collapsed (Photo 9). Most of the collapsed houses were generally old with low foundation rigidity. A gap of up to 50 cm emerged between pile supported buildings and the ground surrounding them.

*Photo 9. House damages by lateral spreading  
(Tokimatsu et al., 2011)*

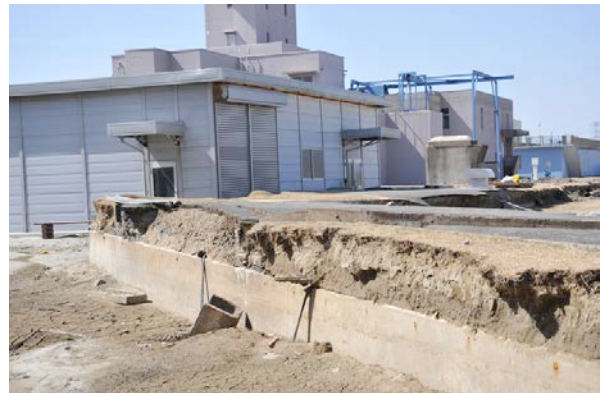
At the Wanigawa purification plant, liquefaction induced ground settlement of up to about 50 cm and uplift of a public utility duct by up to 50 cm (Photo 10). This resulted in a gap of up to 40 cm in the vertical direction between pile supported building and the duct, which severed some of the wiring inside the duct. Horizontal gaps of up to 15 cm also emerged at many joints of the duct, leading large quantities of sand to flow into the duct, which added to the scale of ground settlement. Liquefied ground also caused lateral spreading toward a regulation reservoir at the center of the site, exacerbating ground settlement and raising the water level in the reservoir, inundating roads in the plant.

*Photo 10. Uplift of buried conduit  
(Tokimatsu et al., 2011)*

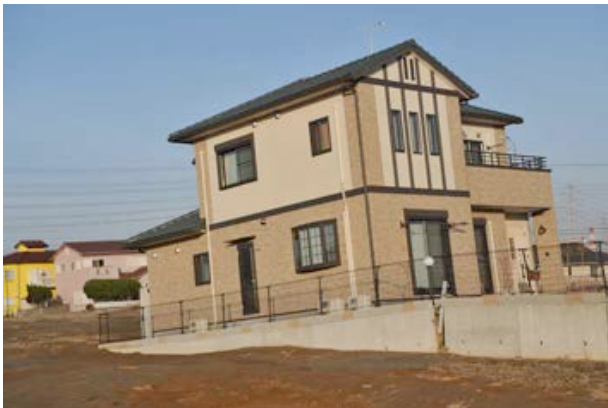
In the Fukashiba and Horiwari areas, liquefaction induced large quantities of sand boiling, causing settlement and tilt of spread foundation buildings (Photo 11), settlement of ground adjacent to buildings supported by a pile foundation, uplift of buried structures and bumps and dents in roads and sidewalks. Boiled sand in Fukashiba measured up to 50 cm thick in some places. When several structures stand close together, they tended to tilt toward the center, where settlement is larger in scale (Photo 12). Several houses located at the end of filled land tilted in the direction of lower ground (outside the land) as the earthfill collapsed due to liquefaction (Photo 11). The northern part of the Horiwari area saw serious damage—an underground drain was uplifted and houses standing along a street settled by up to 50 cm vis-à-vis the road surface or adjacent houses, but the southern part suffered only minor damage. Puddles of water had formed in all of these liquefaction areas, indicating that groundwater level was extremely shallow.

Photo 11. Tilted house on the edge of fill  
(Tokimatsu et al., 2011)

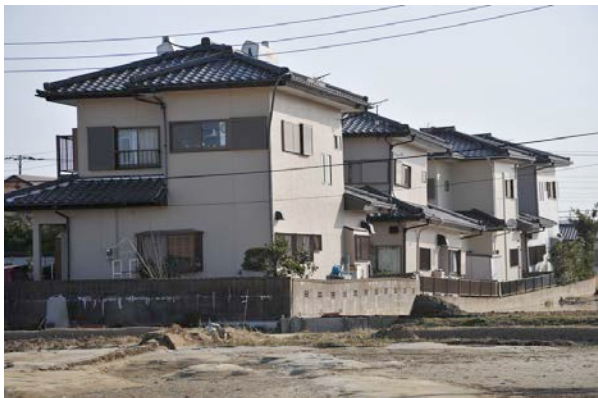
Photo 12. Larger settlement occurring in the middle  
(Tokimatsu et al., 2011)

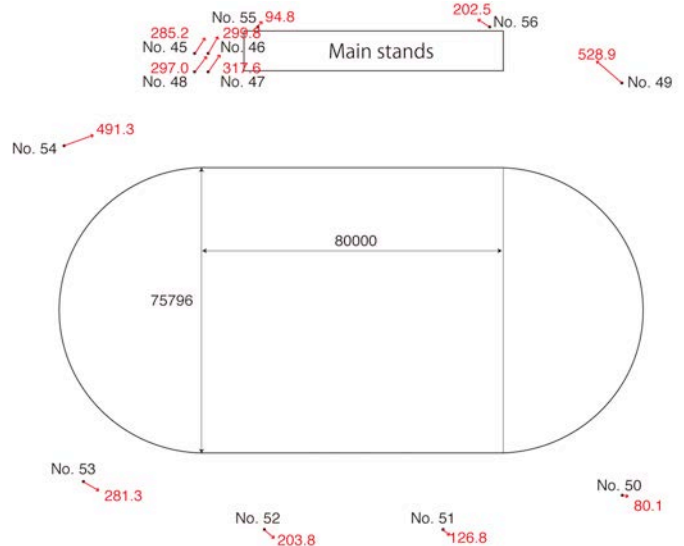
Fig. 19. Vector displacements of pile heads of City Stadium  
(Urayasu, 2012)

soils in Maihama, was under construction and all the piles except for those of the main stand were extensively damaged. Figure 19 shows the horizontal vector displacements of pile head with respect to the main stand. The 2x2 group piles (Nos. 45-48) supporting the small building moved to northeast by 30 cm, while several single piles (Nos. 49-56) supporting an illuminator moved by 8-53 cm. The pile is about 48m long, having diameters of 0.6 m and consisting of a steel pipe-concrete composite pile at depths shallower than about 10 m and pre-stressed high strength concrete piles below.

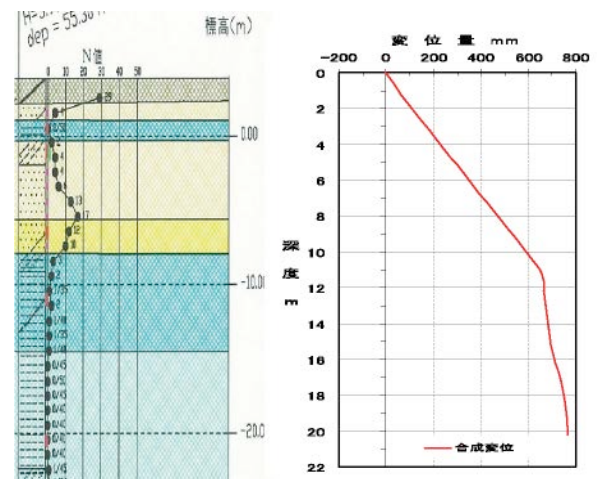
Fig. 20. Soil profile and distribution of pile deformation with depth  
(Tokimatsu et al., 2012)

Figure 20 shows the horizontal displacement profile with depth of Pile No. 49, detected from field survey using a borehole camera and an inclinometer. The pile has failed and bent at a depth of about 10 m, causing an inclined angle of about 1/15 within the surface sandy layer having a thickness of about 10 m. This confirms that the pile failed near the boundary between sand and clayey layers and immediately below the joint of pre-stressed high concrete pile and steel pipe-concrete pile.

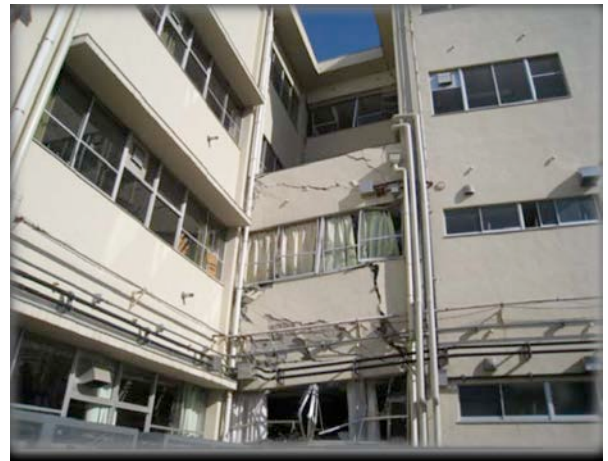
An east part of a 4-story elementary school building in Omiya, Saitama Prefecture, the plan of which is shown in Fig. 21, settled by about 500 mm against the remaining west part, inducing extensive shear failures of the grade beams as well as those of the superstructure near the interface (Photo 13). The building was constructed in 1977-1978 and founded reinforced concrete piles with a length of 36 m and a diameter of 450 mm. The near surface soils around the building do not consist of liquefiable sandy soils but humic soils, the thickness of which increases towards the north.

Photo 13. Shear failures on beams (Tokimatsu et al., 2012)

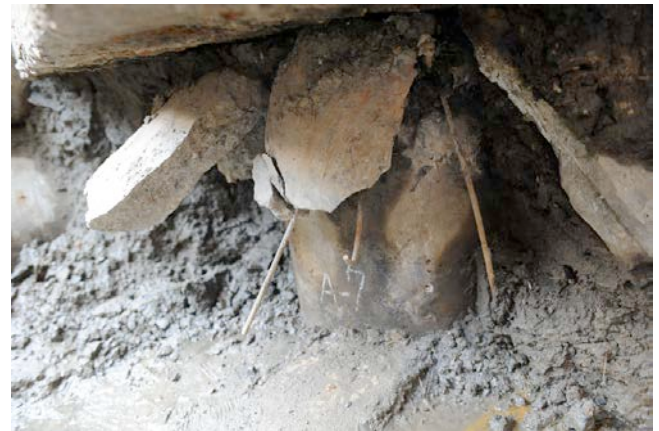
An excavation survey confirmed that the piles on the northern part failed near the pile heads (Photo 14), with those on the

southern part undamaged. The uneven performance of pile foundation within a building could have caused the uneven vertical displacement, and thereby inducing the shear failure of beams. The excavation survey also showed that the ground on the north settled more and induced a longer projection of piles on the north side of the building. This suggests that the difference in soil condition below the building might have induced the uneven failure of pile foundations within the building.

Photo 14. Damage to pile head

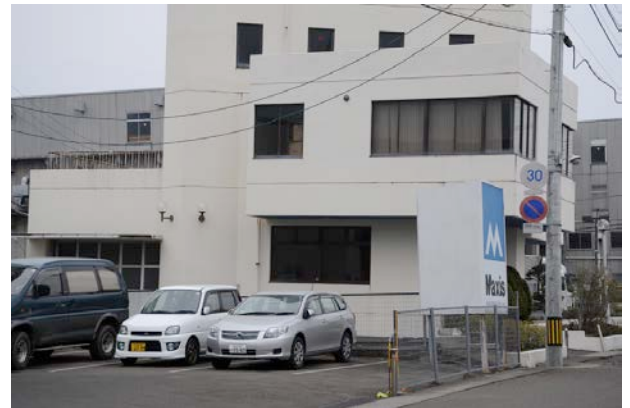
In the western part of Oroshimachi-Higashi area (Fig. 22), soil liquefaction induced sand boiling, settlement of ground adjacent to structures supported by a pile foundation, uplift of buried structures, and bumps and dents in roads and sidewalks. Settlement of ground surrounding pile-supported buildings measured about 10 to 20 cm. At least two buildings apparently supported by a pile foundation tilted remarkably

*Photo 15. Tilt of pile-supported building (Oroshimachi) (Tokimatsu et al., 2011)*

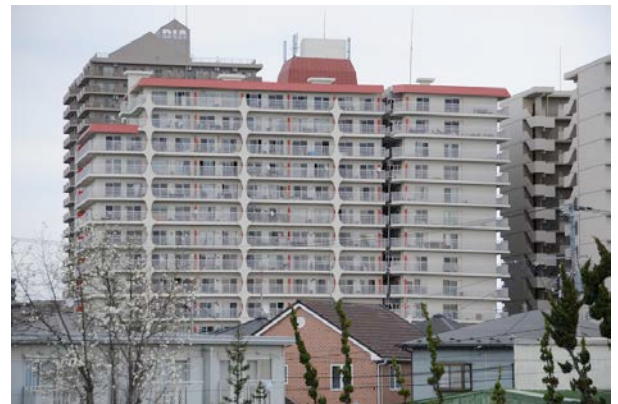
(Photo 15). A similar pattern of building damage associated with pile failure involving soil liquefaction was observed in the Fukumuro area. A 14-story, steel-reinforced condominium complex, consisting of two buildings connected in an L-form with expansion joints, had pile damage (Photo 16). It was completed in 1976. Along the bottom of the letter L (on the south side) runs a national highway. It has been reported that the complex's nonstructural walls suffered shear fractures in the 1978 Miyagiken-oki Earthquake. In the March quake, the southern building tilted by about 1 degree southward as its foundation on the south side settled. There were large cracks in nonstructural walls of various parts of the building, but no significant damage was observed in the major structural components. The ground settlements around the neighboring buildings were about 10 cm.

*Photo 16. Tilt of pile-supported 14-story building (Fukumuro) (Tokimatsu et al., 2011)*

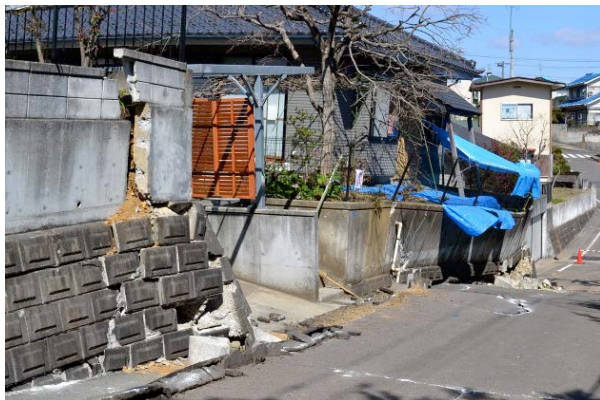
Figure 23 shows a damaged area in Oritate 5-chome, where many retaining walls were broken. At the lower part of a slope (P1 in Fig. 23), retaining walls had collapsed as if pushed out by backfill soil (Photo 17). Above that point, at P2, ground under a retaining wall was raised. It is believed that the

Photo 17. Damage to retaining wall (Tokimatsu et al., 2011)

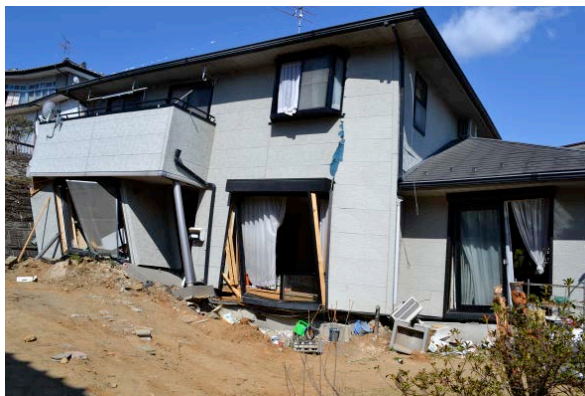
A house that straddles the landslide area and a cut slope was broken around the boundary (P5). Severe damage to houses concentrated at the foot of the landslide area, shown with a shade in Fig. 23 (Photo 18). Damage was greater at the end of the landslide block because ground deformation became greater in both horizontal and vertical directions.

Photo 18. Damage to wooden house (Tokimatsu et al., 2011)

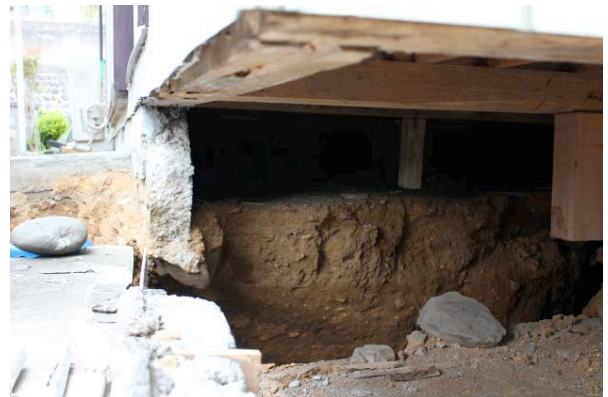
Closer to a valley at P2, the retaining wall shifted about 1 meter to the valley side, causing ground to sink and leaving a void below the foundation, as in Photo 19. At the lower part of the slope, a residential land plot was destroyed as if pushed out, as in Photo 20 (At P3 in Fig. 24). Figure 24 shows the points of tension and compression found from these examples, which indicates that the landslide area was a shaded part in the figure. Comparing it with an old topographical map (around 1964) finds that the area roughly coincides with an earth cliff in the old landscape. The landslide occurred in the residential land developed by widening earthfill along the cliff. Residents

Photo 19. Void below foundation (Tokimatsu et al., 2011)

said that the groundwater level in the neighborhood is extremely shallow at about 1 meter deep, which is considered to be a factor leading to the landslide.

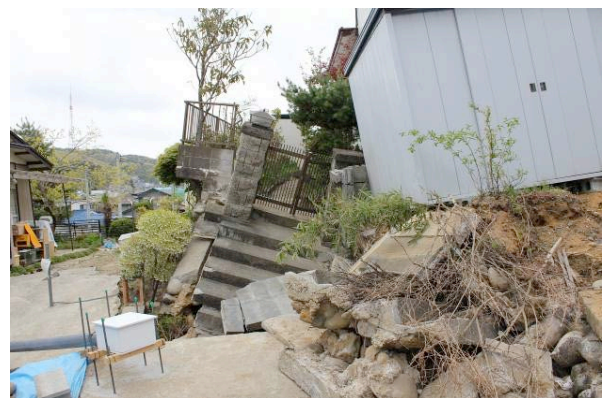
Photo 20. Failure of reclaimed fill (Tokimatsu et al., 2011)

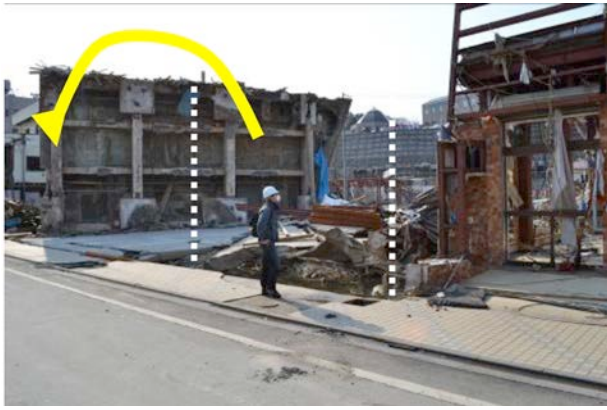
Photo 22. Toppled building A (Tokimatsu et al., 2011)

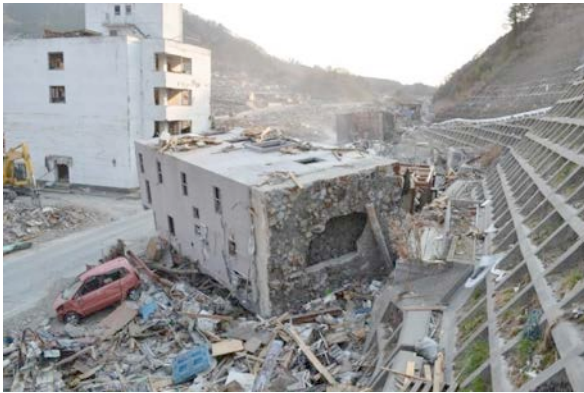
At point B, a four-story, reinforced concrete building with a pile foundation lay on its side (Photo 23). The building used to stand at point B0, from which it was swept toward the mountainside by about 70 meters. A PC pile with a diameter of 300mm was hanging from the pile cap. The pile's head barely remained connected with the cap by reinforcing steel, but the rest of the pile suffered comparatively minor damage. Most of the other piles were found at point B0, either fractured at their heads or head joints, or pulled from the ground with damage at or near their heads. The state of destruction of these piles showed that bending and tensile forces had applied. At a neighboring five-story, reinforced concrete building (at P2), adjacent ground apparently settled, indicating soil liquefaction. It is possible that, when soil liquefaction had lowered the shear strength of the ground, horizontal and buoyant forces of the tsunami applied to the building, pulling the piles out of the ground or causing complete failures at the pile heads. At point D, a two-story, reinforced concrete building with a pile

Photo 23. RC building B carried 70 m away and toppled (Tokimatsu et al., 2011)
